Sedimentation Rates in Paired Streams During High Precipitation Events on Elk Creek

Sedimentation rates in paired streams during high precipitation events on Elk Creek

Joey Radel and Dr. Dan Ressler

Department of Earth and Environment Sciences, Susquehanna University, Selinsgrove, PA, 17870

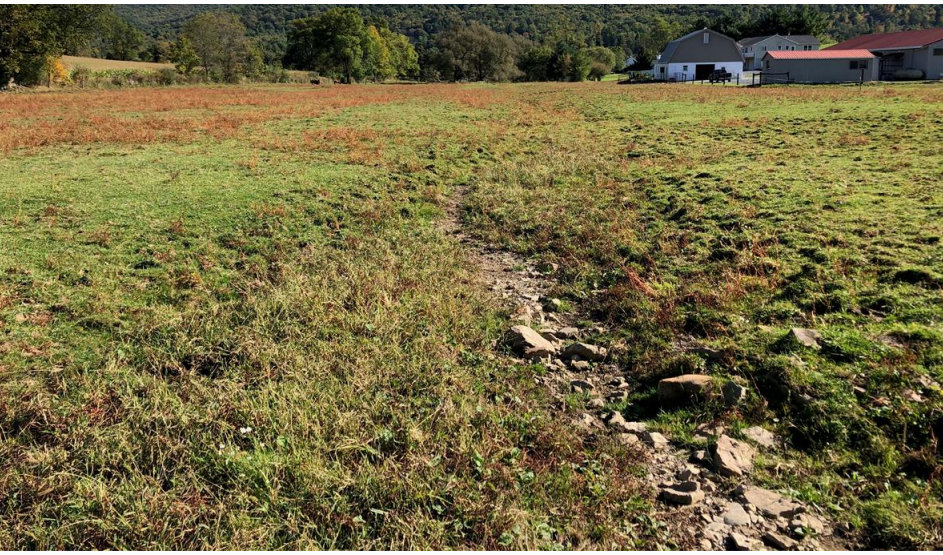
Figure 3: A photograph of the Barnyard and the stream in the Barnyard.

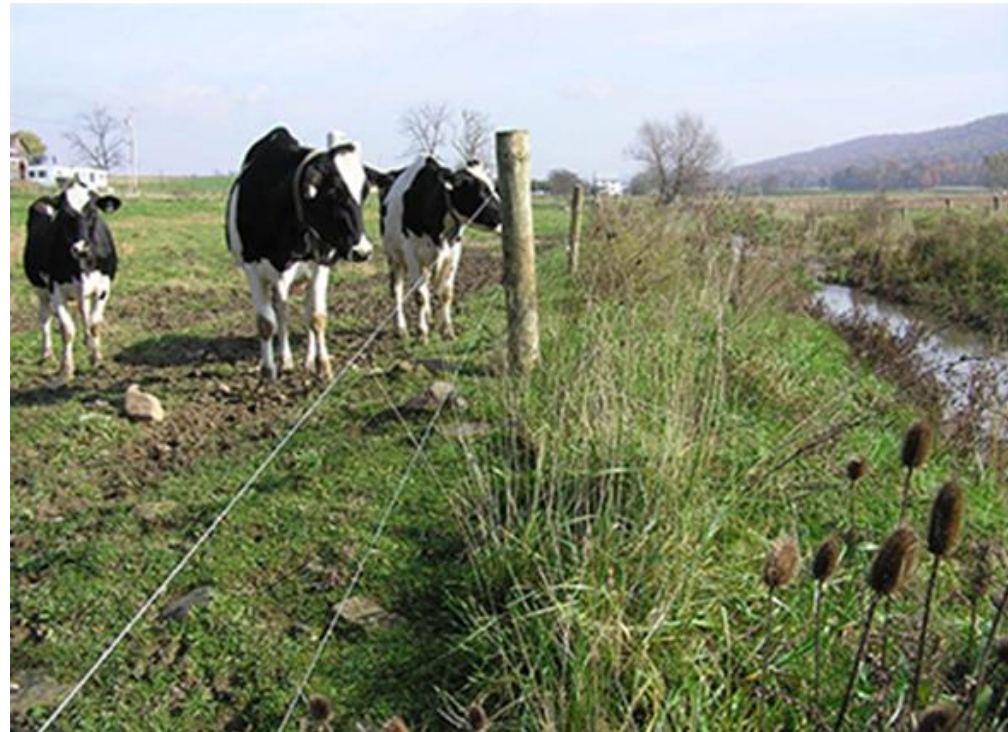
Figure 7: A photograph of what a restoration might look like.

The two watersheds were drastically different. After test and calculations were done, the results came back with numbers that show this would be a great opportunity for a restoration. A restoration would help decrease the amount of sediment lose into Elk Creek. With decreasing the loss of sediment and loser the amounts of ammonia and nitrate in the water it would increase the water chemistry. Not only would the water chemistry improve, but also the soil lost would decrease keeping the soil in the ground improving the land and soil. .
